Test Report on the Effects of 6 GHz Unlicensed RLAN Units on Fortson to Columbus Microwave Link

**Prepared in Partnership with
Southern Company Services**

June 21, 2021

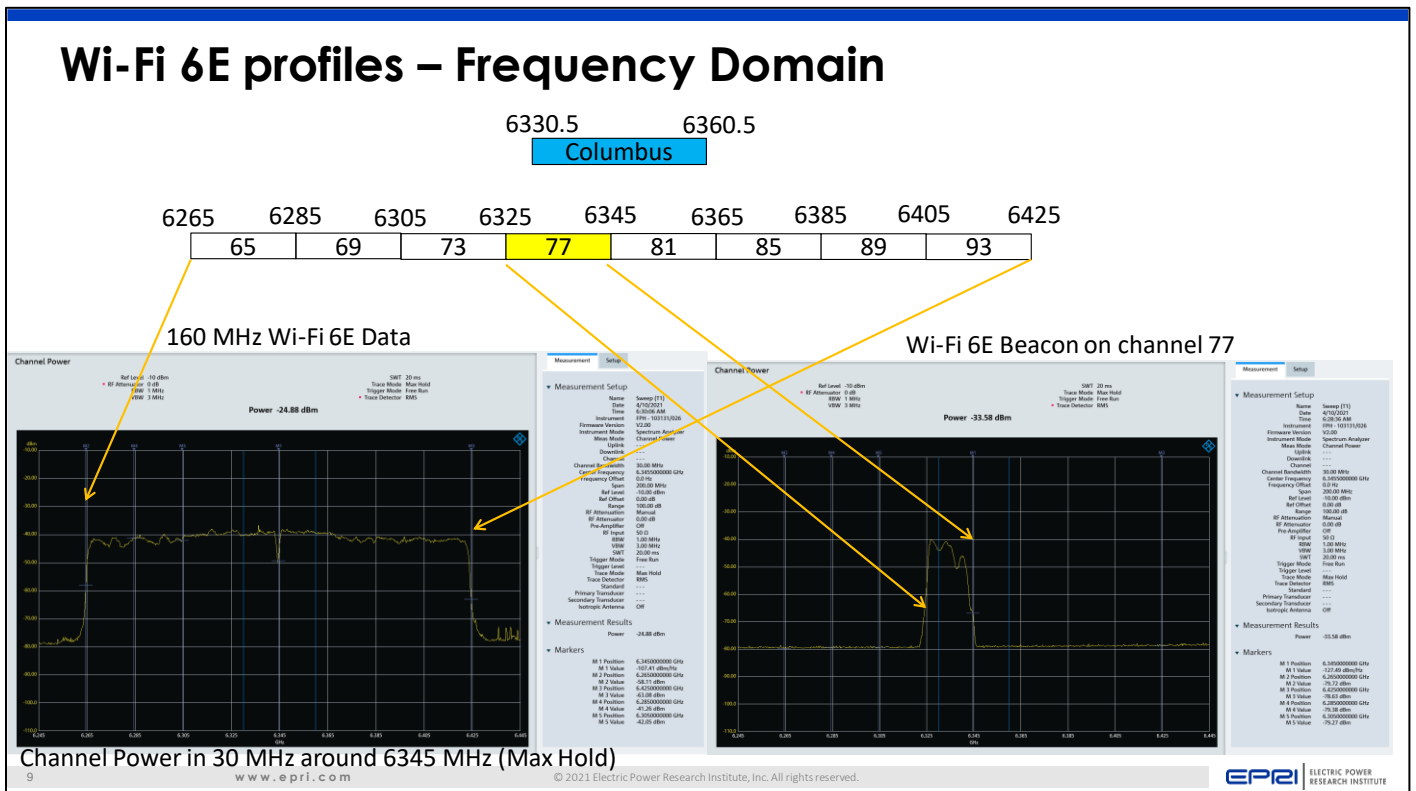
Figure 18: Frequency Domain view of Overlaps

- The frequency domain was also measured as shown below. Of note, the fixed frequency of the licensed link to Columbus allowed Wi-Fi 6E channels 77 or 81 to be used and fully overlap Columbus's receiver in either 80 or 160 MHz data bandwidth.

- Note that the frequency domain plots are not calibrated for signal levels – the analyzer must be air coupled to the LPI given the lack of external antenna connections allowed on LPI's. Calibrating an air coupled measurement accurately was beyond the scope of our testing facilities.

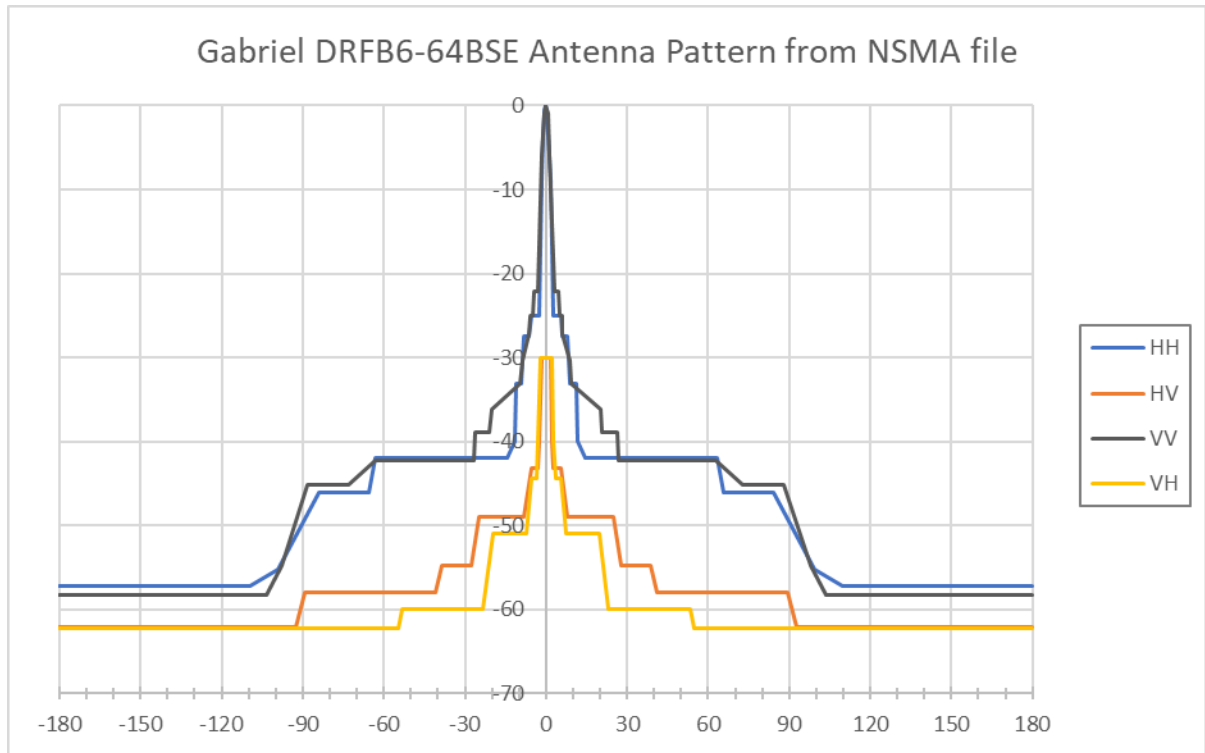
Figure 20: Gabriel DRFB6-64BSE Antenna Pattern

The receive antenna specifications at Columbus are a key input to the impact testing planning and execution. Columbus has the original Gabriel Electronics DRFB6-64BSE antenna which has a 39.1 dB gain factor, a 1.7 degree 3 dB beam width, and the pattern produced from Gabriel's spec sheet below.

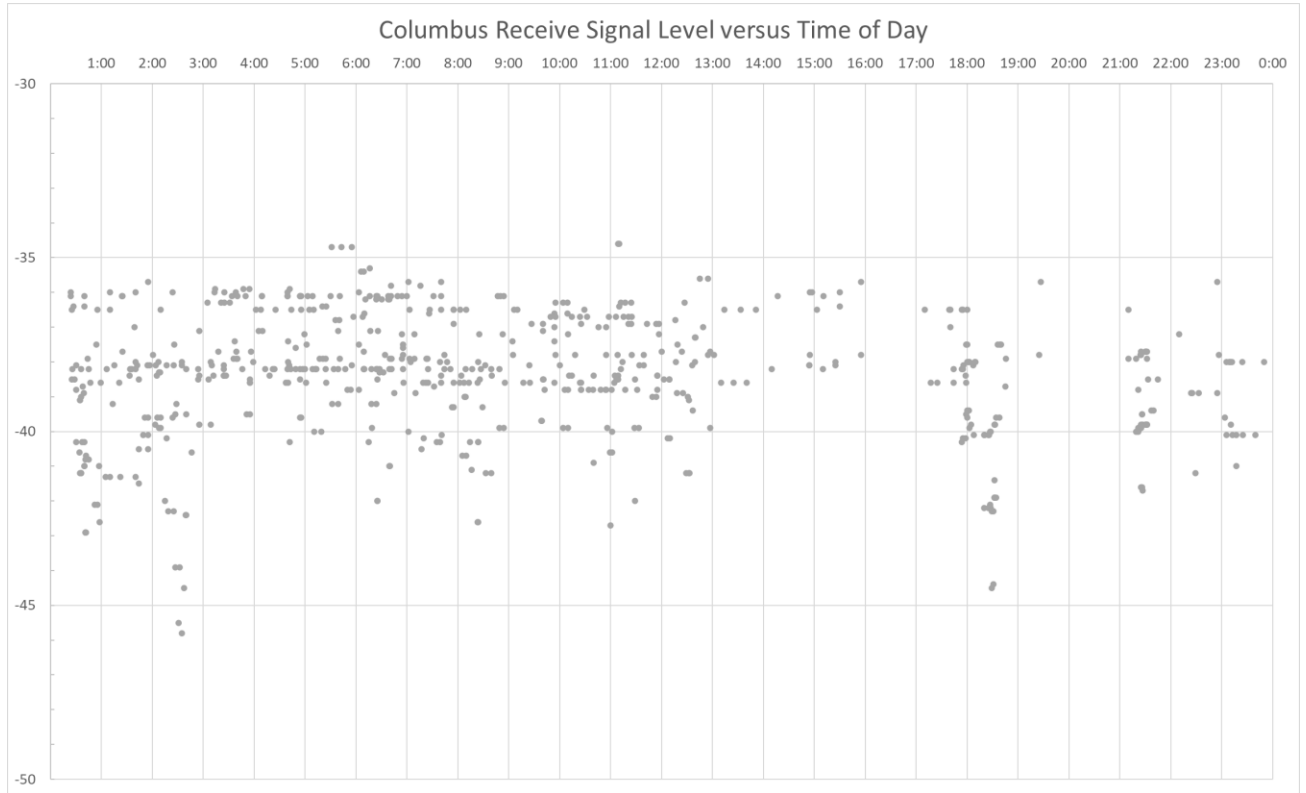
Figure 21: Columbus RSL versus Time of Day over 1 month

RSL history from the Network Management System (NMS) was also pulled and showed the path having a median measurement of -38 dBm across a month of 24 hour per day monitoring with a minimum of -46 dBm and a max of -34 dBm (standard deviation of 1.8 dBm). Given the spring season and the use of a single month (maintenance and updates to the link had rendered previous data unusable), the maximum fade span of 12 dB was not surprising. The data is plotted below, note that the path does show fade activity up to the noon hour on some days and it restarts around 6 PM local time. On one day of the testing the path was fading due to fog and prevented beginning the testing until nearly 11 AM. The baseline fade margin was tested at the beginning and end of each group of tests to ensure the path remained stable and the measurements were impacted by RLAN interference and not atmospheric fades. Through the course of four days of testing and nearly twenty baseline checks the fade margin was measured at 31.5 dB or 31.6 dB. These are nearly identical given the accuracy of the test equipment so 31.55 dB (the average) was used in this report. The only exception is the baselines were measured for each modulation when testing sensitivity to the modulation index. These tests were run late in the day and measured 32.1 dB for 1024QAM.

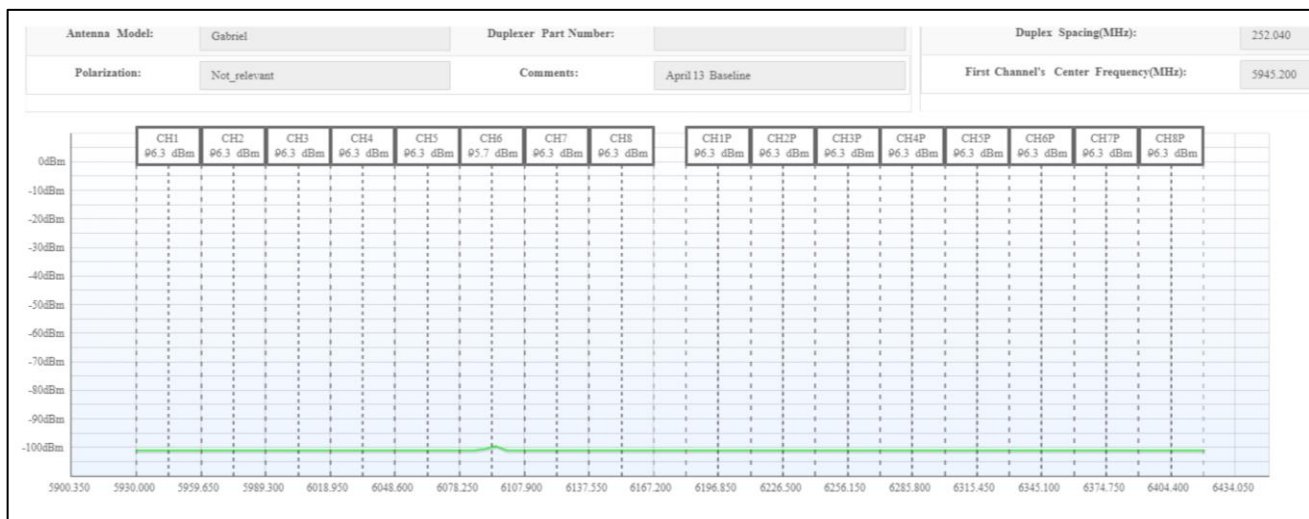
Figure 22: Columbus Wavence Receiver Scan with Fortson transmitter off

The next step in the process was to observe received signal at Columbus both with and without transmit operation at Fortson to determine spectrum occupancy and levels in normal operation and any pre-existing interference. None was found as shown in the pictures below. The small signal around 6093 MHz is most likely a reflection of the Columbus transmitter since it is on the Columbus transmit channel. The scans follow measured levels reasonably closely (Fortson RSL at -36.3 dBm, noise at -99 dBm [thermal], -96.5 dBm [with receiver noise figure of 2.5 dB]).

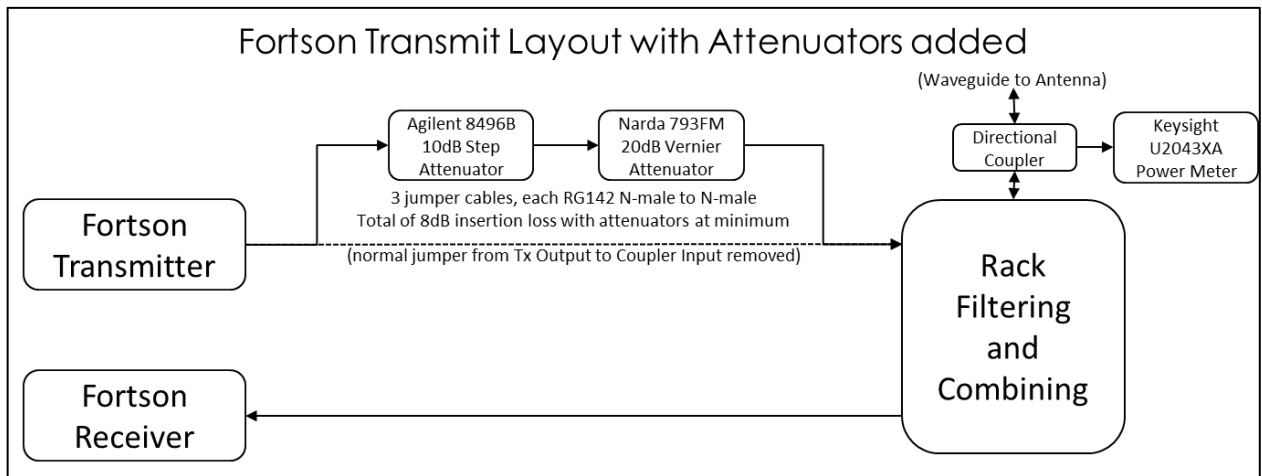
Figure 24: Fortson Transmit Test Setup

Since the transmit power control on the Fortson microwave transmitter has limited dynamic range, and it is desired to measure impacts down to the FCC reportable level (-6 dB I/N, equivalent to a 1 dB reduction in fade margin), adjustable attenuation was added inline with the Fortson transmitter. Below is the diagram of this arrangement – the step attenuator allows setting a range for measurement and the Vernier attenuator provides continuously variable attenuation for measurements.
